## The Environmental Impact of Gully Erosion and Its Implications for Soil Loss in Northern Adamawa State, Nigeria

### Abstract

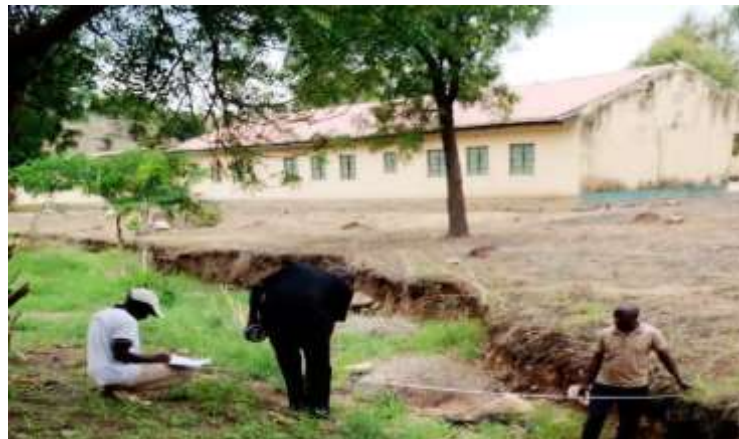
**Plate I:** A Secondary School Degraded by Gully Erosion in Pakka, Maiha Local Government Area

equals to  $0.2\text{km}^2$  ( $200\text{m}^2$ ) radius for short gully and more than  $200\text{m}^2$  for long gullies. Total number of 163 gully sites were identified in the five Local Government of the study area as depicted in Plate I.
