Geospatial Assessment of the University of Maiduguri Campus Master Plan

Charles Vashala, Ikusemoran Mayomi and Daura, M.M.

Department of Geography, University of Maiduguri, Borno State

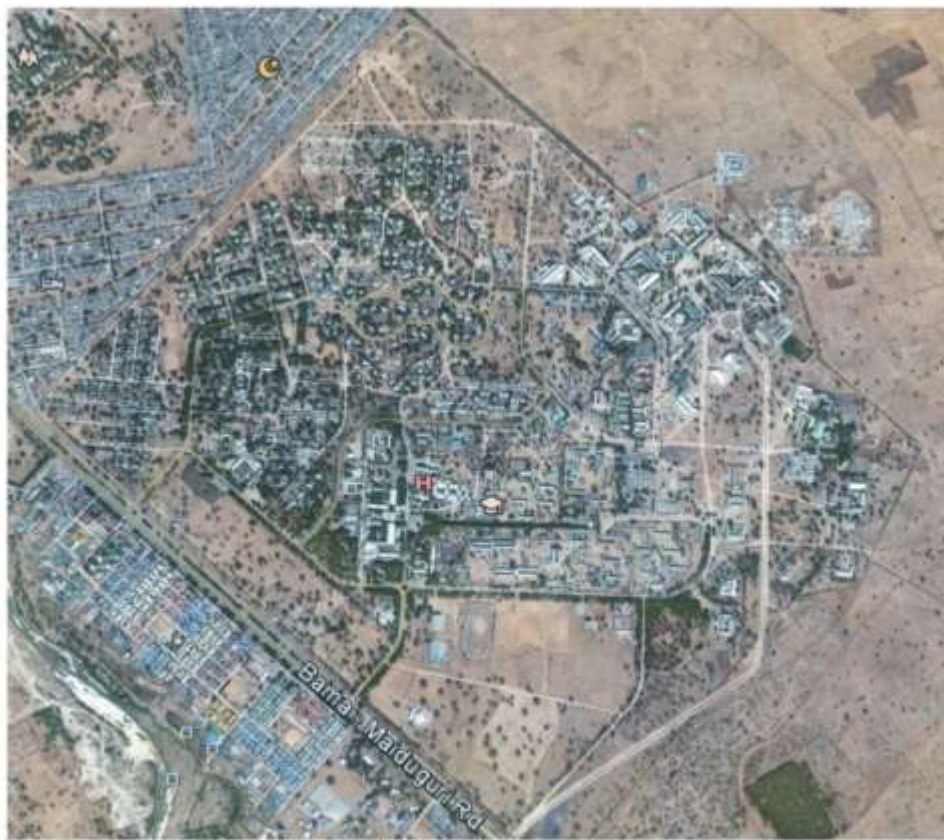
Plate 2: Google Image of Unimaid Campus in Jan.2015

January 2015 Google Image of Unimaid campus

The three main data that were used for this paper were: (i) The 1978 University of Maiduguri campus master plan (Plate 1a). (ii) the 1984 reviewed master plan of the University of Maiduguri campus (Plate 1b) and (iii) the 2015 (January) Google image of the University of Maiduguri campus (Plate 2). While the first two were obtained from the Physical Planning Unit of the Works Department of the University of Maiduguri, the third was derived from Google Earth Pro (online).

The map obtained from the Google was referenced to the existing 1984 reviewed master plan and was resampled to that of the 1978 so as to enable the maps to have same number of rows, columns and

other parameters that will make them overlay on each other. Roads and other features of interests were then digitized from the Google map.

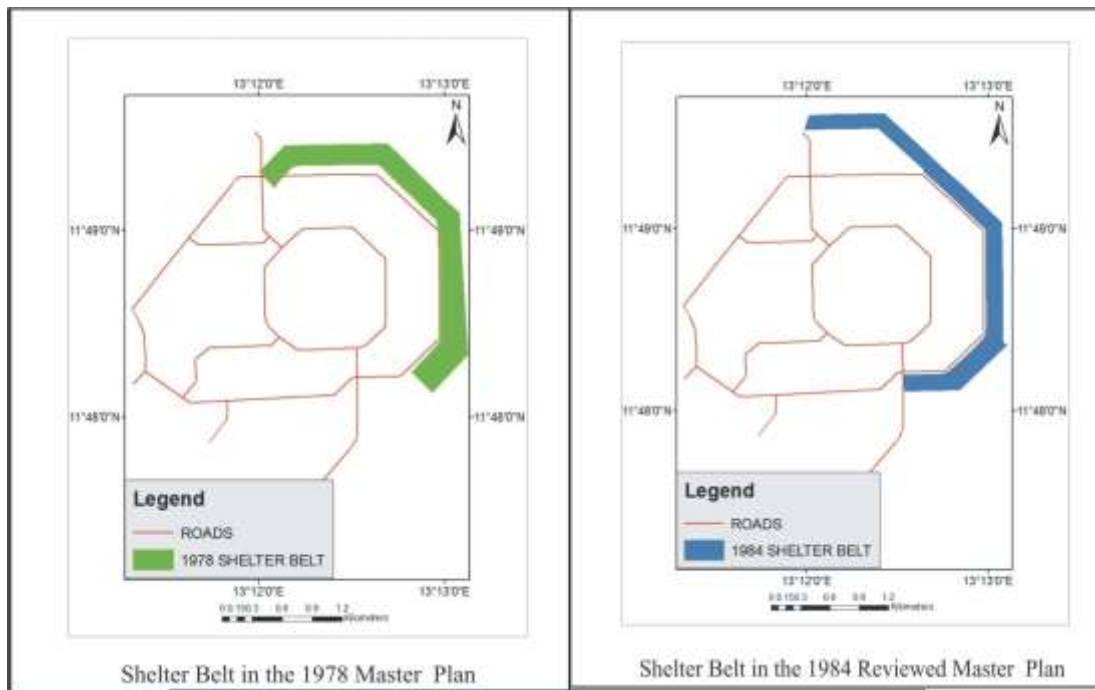
The following modifications were identified in the 1984 revised master plan over that of the 1978. Reduction in area landcover in the previous land for shelter belt, academic facilities and junior staff housing, while senior staff housing were allocated increase in land area. Sewage treatment plant and university farm which were not in the 1978 master plan were allocated in 1984 as shown in Fig. 2.

Figure 2: Shelter belt areas in 1978 and 1984 master plans

The land area for shelter belt in the 1978 master plan was calculated to be 87 hectares while the land area for shelter belt in the reviewed 1984 master plan was found to have decreased to 73.79 hectares. The difference in land area for shelter belt between the

1978 master plan and the reviewed 1984 master plan was calculated as 13.21 hectares. Hence, it was concluded that the 1978 master plan placed more importance to shelter belt than the 1984 revised University of Maiduguri master plan.

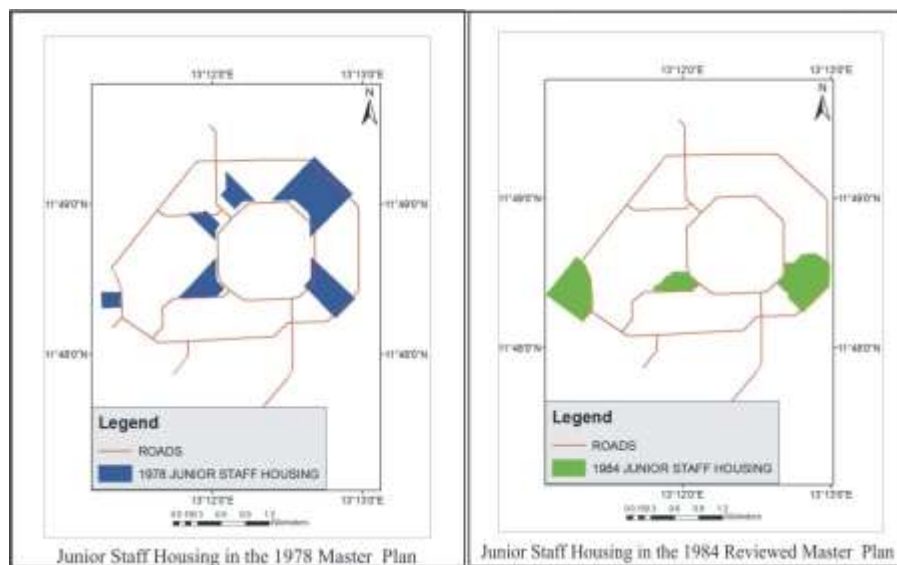
Figure 4 shows the land area designated for junior staff housing in both the 1978 and the revised master plan of 1984.

Figure 4: Junior staff housing land areas in 1978 and 1984 master plan

As shown in Figure 4, the land area for Junior Staff housing plan on the 1978 master plan was 90.53 hectares while that of the reviewed 1984 master plan decreased to 65.81 hectares. Hence, the difference in the land area for Junior Staff housing plan between the 1978 and the reviewed 1984 master plan was 24.71 hectares. This shows that the land area for 1984

revised master plan is less than the 1978 master plan. This decision might be to the disadvantage of the university especially at this period when most staff of the university prefer to stay within the campus for security reasons as a result of insurgency. Hence more land area for residential purposes are required.

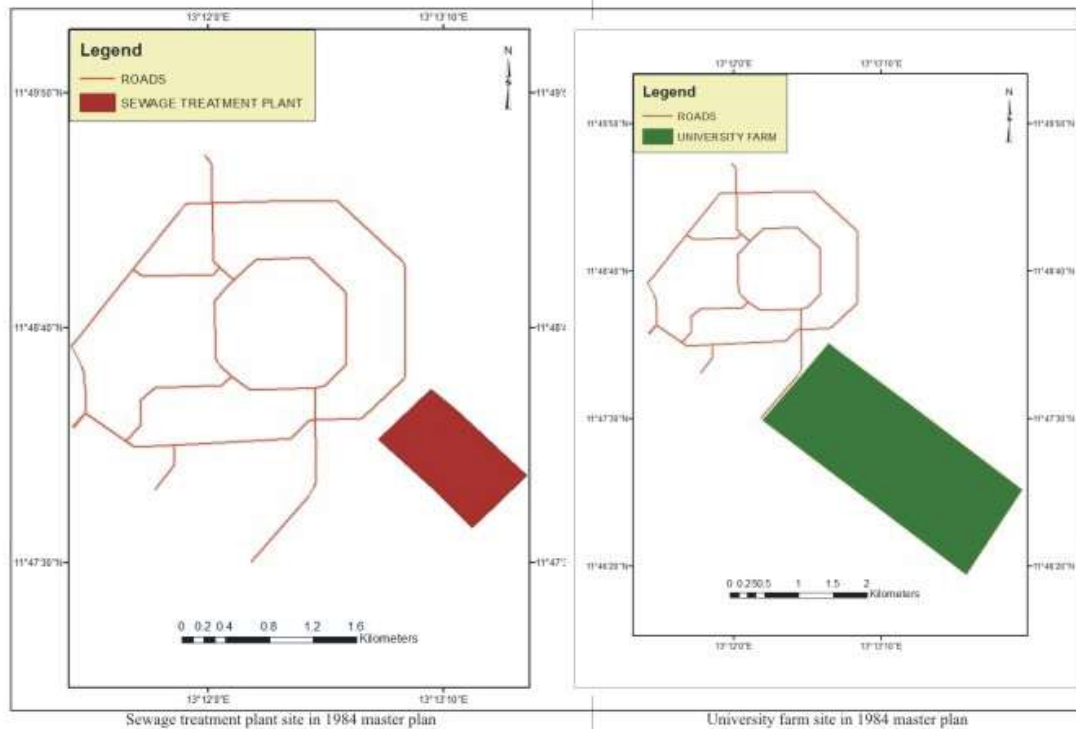
It was obvious in the 1978 University of Maiduguri master plan that no provision of land area for sewage treatment plant and university farm was made. However, the reviewed 1984 master plan created 78.84 hectares of land for sewage treatment. The University farm around gate three covering a land area of 528.49 hectares was also created as shown in Figure 6.

Figure 6: Sewage treatment plant and university farm land areas in 1978 and 1984 master plan

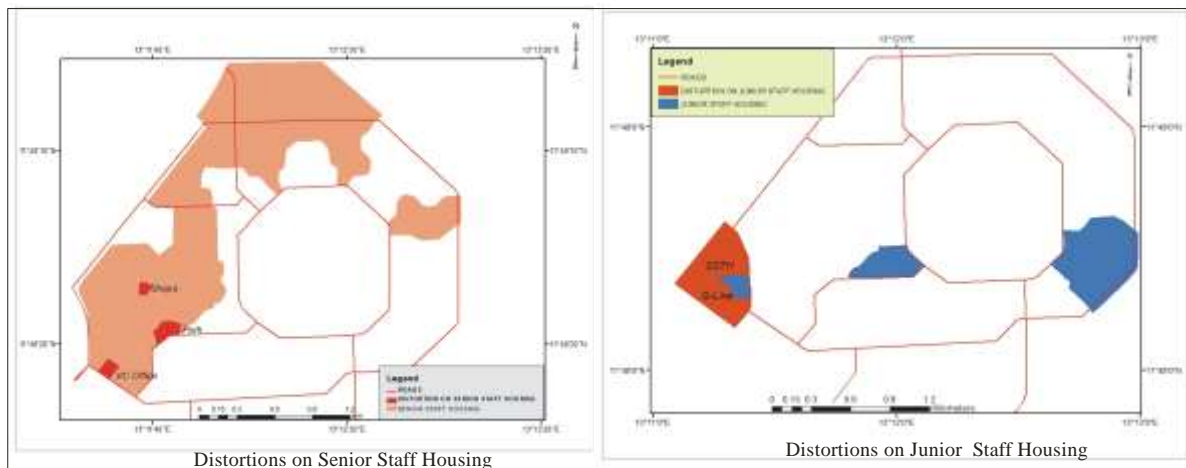
Figure 8 shows the distortions on the senior and junior staff housing areas.

Figure 8: Distortions on senior and junior staff housing land areas as at 2015

Out of the 225.52 hectares of land planned for Senior Staff housing, 4.4 hectares was distorted by the following:

1. Park (Love Garden) located opposite Fire Service Unit, around SSTC staff quarters.
2. Alliance France' situated opposite H-Line and surrounded by commercial shops.
3. Vice-Chancellor's Office complex located close to Gate 1 roundabout.

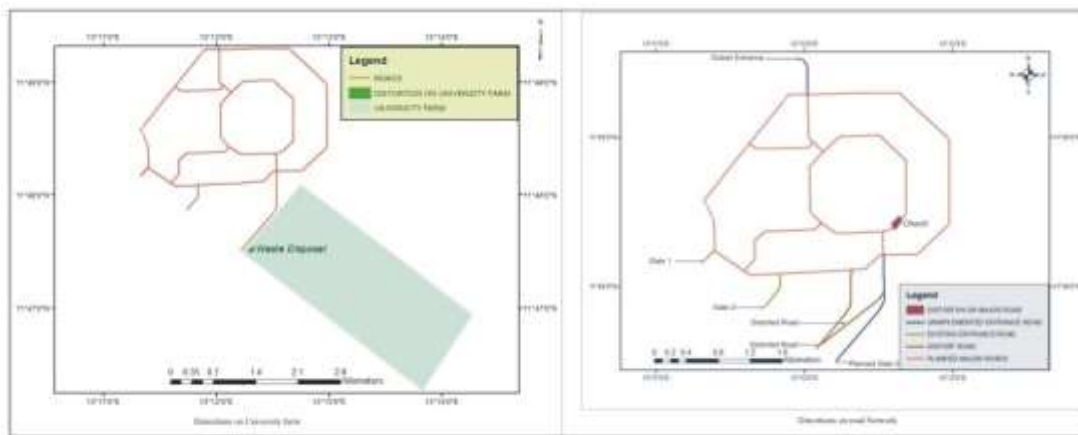
Figure 11 indicates that the distortion on the area planned for University farm and road network.

Figure 11: Distortion on University farm and road network as at 2015

The only distortion on University Farm is the waste disposal site around Gate 3. According to the 1978 master plan, the entrance road for vehicles into the University of Maiduguri campus was supposed to be through Gubari around Gate 5 and Gate 3 on Bama road. However, today the vehicular entrance into the University of Maiduguri campus is through Gates 1, 2 and 3 which are all located along Bama road. The current Gate 3 as shown in Figure 12 does not conform to its actual location in both the 1978 and 1984 University of Maiduguri master plan. The planned Gate 3 road (shown with blue line in Figure

11) supposed to run from Bama road and link the road that passes through the churches. However, the existing Gate 3 starts from Bama road with two arms. The first runs to the right and join the planned Gate 3 road, while the left arm joins the road that runs from Gate 1 towards Works Department just adjacent to Murtala Hall (Girls Hostel). Another distortion found on the planned major road was the churches built around the Chapel of Grace. The distortion blocks the major road that leads to Center for Entrepreneur and Enterprise Development from the Church Junction.
